WASTEWATER DEPARTMENT

RE: DRY WEATHER CSO AT MECHANIC STREET

The purpose of this letter is to detail the events that led up to the dry weather CSO event from Mechanic Street CSO that occurred all of April 2015, through May 15, 2015.

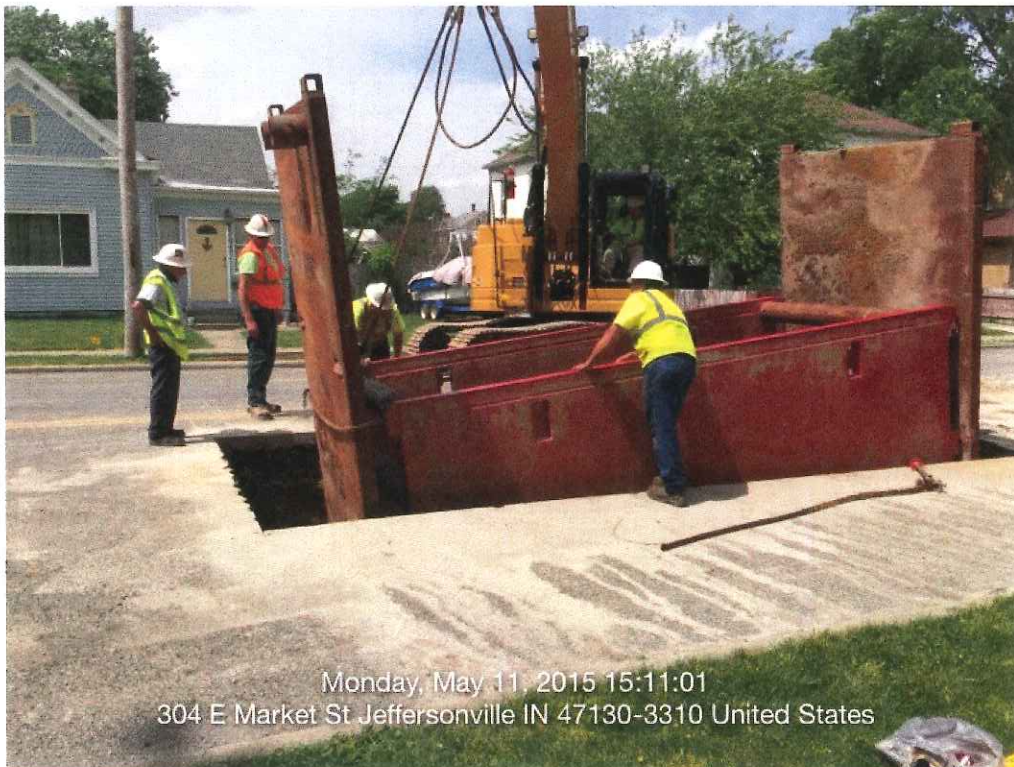
Photo 1 – Installation of one of the two trench boxes on Market Street.

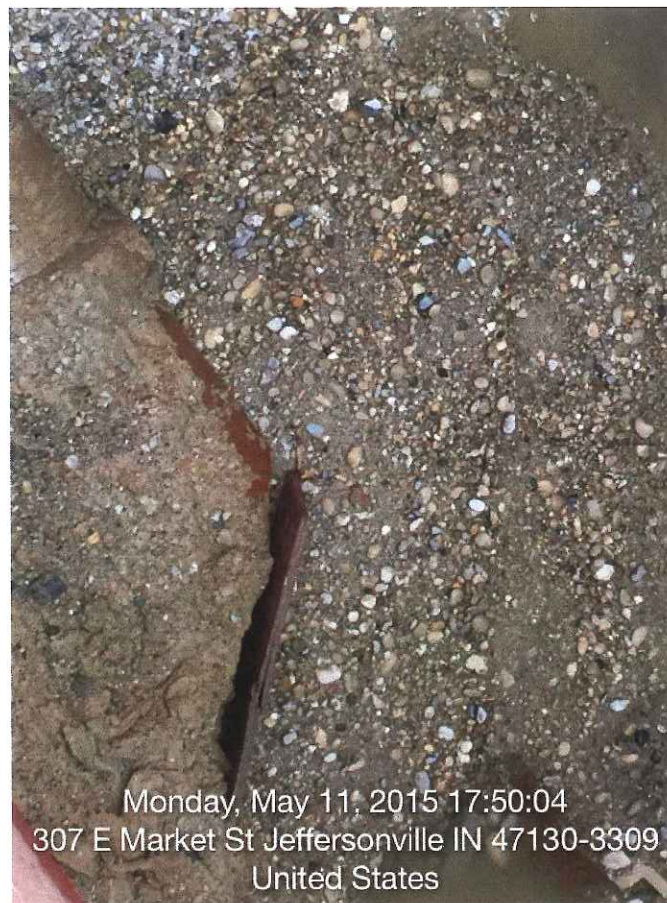
Since the jet cleaning efforts did not clear the blockage, the Department had no choice to dig up the sewer in the area of the blockage. This sewer receives all of the flow in the northwest portion of the combined sewer system. See the attached map which depicts the area served by this portion of the combined sewer system. The Construction staff was mobilized right after noon to begin the dig. The sewer is approximately 15 feet deep at the location of the dig site. The Department does not own any safety equipment (trench boxes) to protect staff at that depth, so equipment had to be rented from a safety equipment company in Louisville. Once the trench boxes were obtained (**Photo 1**), the digging began and the trench boxes installed in the hole at the location of the blockage based on the location identified by the sewer cleaning efforts. The trench walls consisted of Indiana clay which did not account for all of the sand and rock removed during all of the cleaning efforts. The sewer was vitrified clay pipe (VCP) and was in fairly good condition considering there was no bedding under the sewer pipe. When the sewer pipe was exposed, the source of the blockage was not found. Excavation continued to the extent of the trench box. Since the VCP pipe was damaged during the excavation, it had to be repaired before the trench boxes could be moved. Since there was a break in the VCP pipe in the trench, Department staff tried again to use the combination sewer cleaning equipment to remove the blockage. This effort brought back more sand and large gravel, which was very puzzling, since there was no evidence of that material in any of the excavation to reach the VCP pipe. (See **Photo 2 & 3**)

Photo 3 – The sand and river rock from the collapsed sewer on Market Street

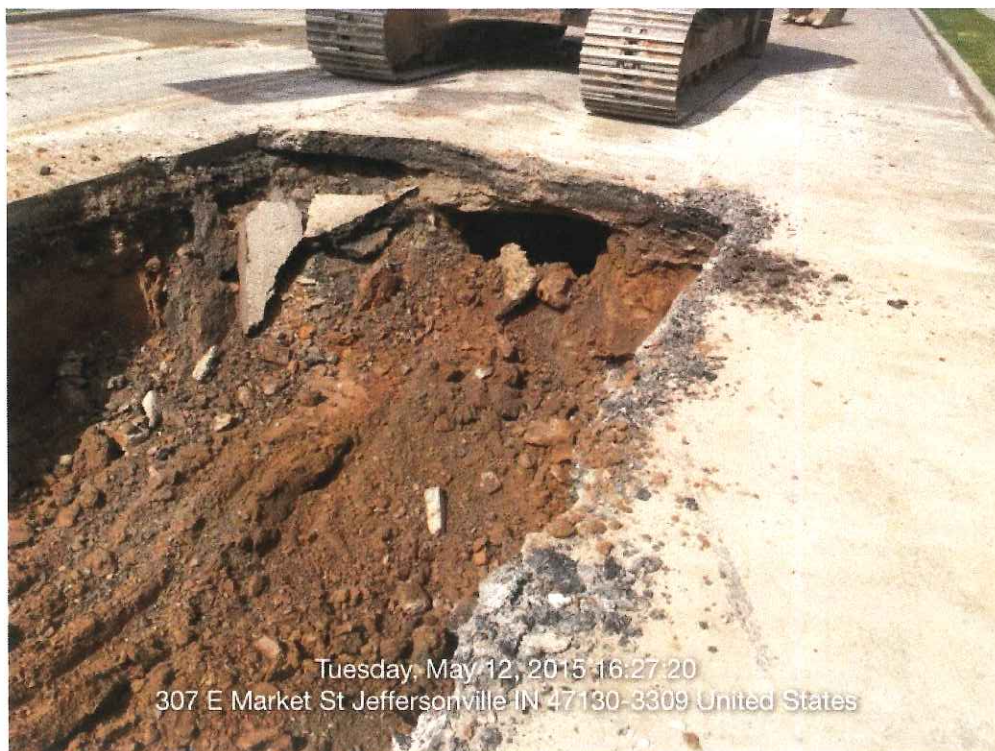
Photo 4 – The first sign of the sewer collapse with the void under Market Street.

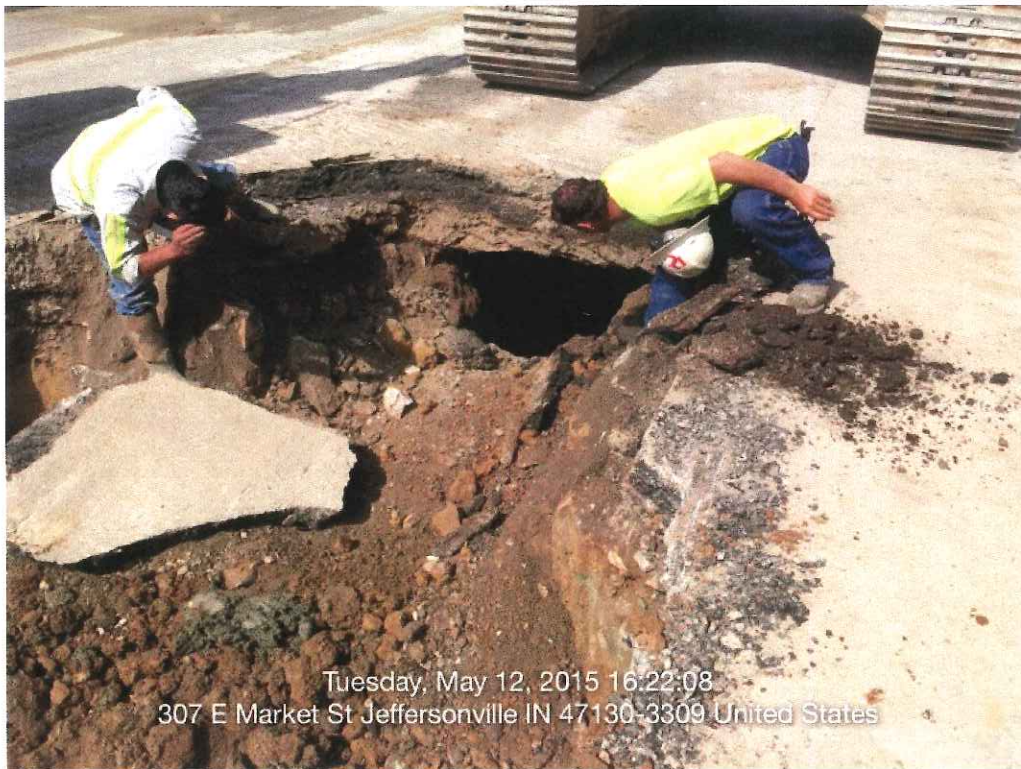
Photo 5 – Photo showing the void under Market Street

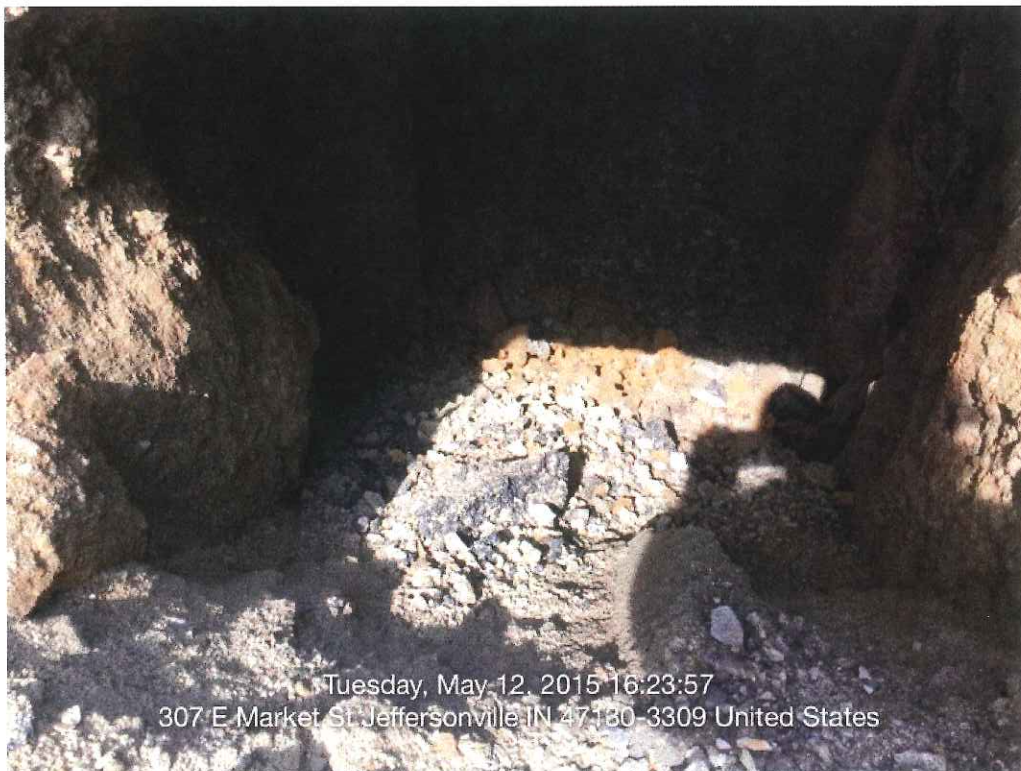
Photo 6 – Close-up Photo of the extent of the void under the road and over the collapsed sewer

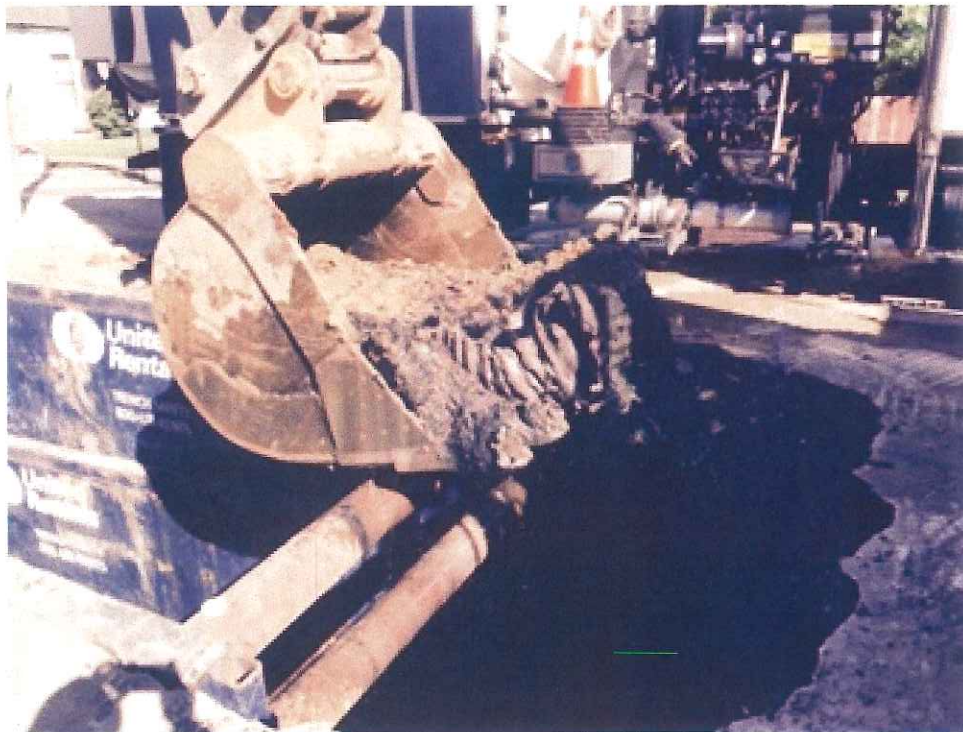
Photo 7 - Photo showing a portion of the collapsed corrugated metal pipe

In discussions with two members of the Sewer Board and its attorney, it was decided that it was more appropriate to declare an emergency and hire a contractor that had experience in excavation at the depth of the sewer. A local contractor was contacted to complete the sewer repair. After the contractor was completely mobilized, excavation continued. Since there was too much debris in the sewer to get a CCTV camera into the exposed sewer, a visual observation was made and it revealed the blockage further upstream in the sewer and the sewer appeared to be a corrugated pipe. The excavation continued, and as the VCP pipe was removed, a new 18-in SDR 21 PVC pipe was installed. As the excavation continued to the location of the blockage, a void under the road was exposed (**Photos 4, 5 & 6**). The source of the sand and gravel was the backfill used when the corrugated pipe was used to replace the VCP sewer. Once the blockage was reached additional corrugated pipe was encountered. The corrugated pipe was severely corroded and appeared to be the source of the sand and gravel and inflow into the sewer. Approximately 115 linear feet of corrugated sewer was removed and replaced with 18-in PVC (**Photos 7 & 8**).

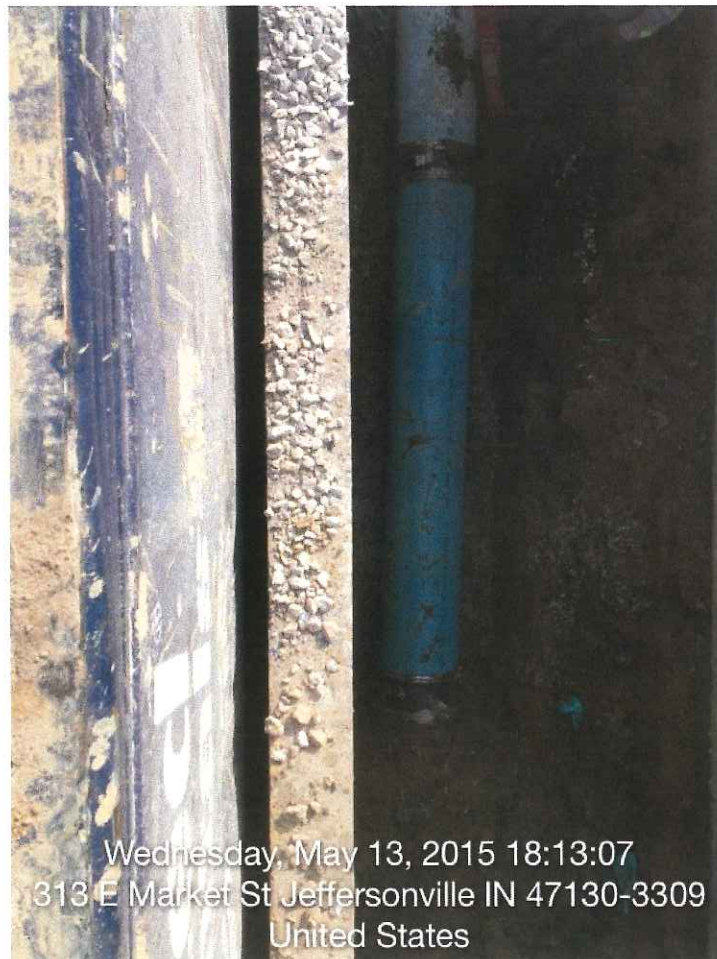
Photo 8 – Photo showing the final connection of the new 18-in PVC to the VCP sewer

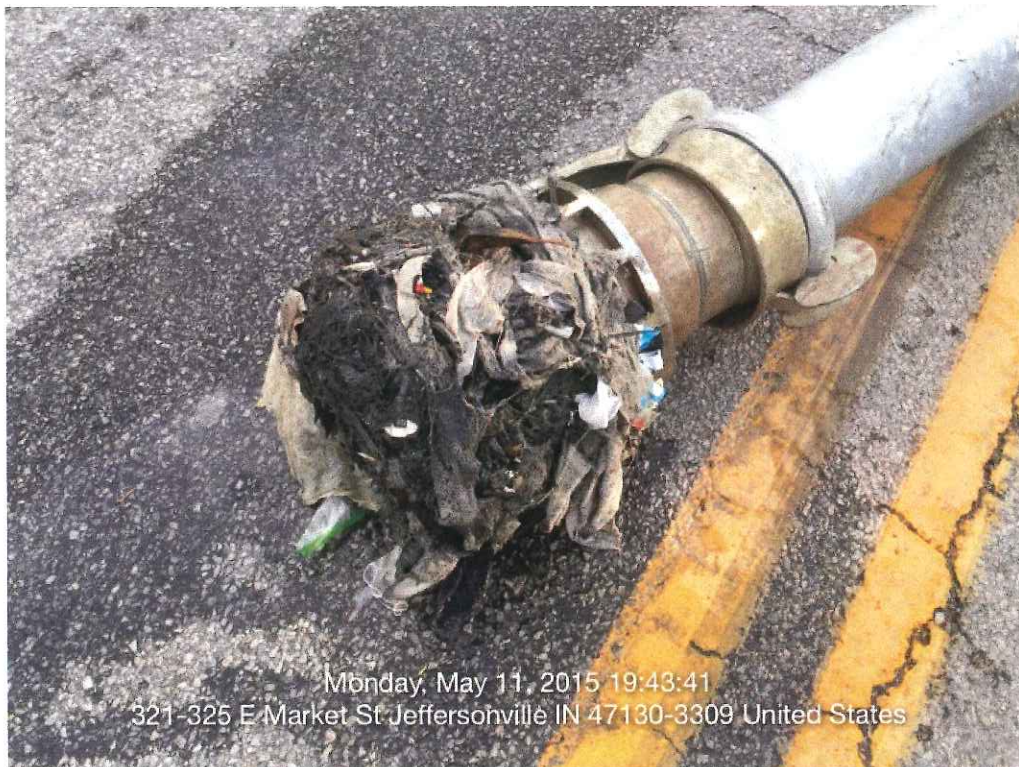
Walnut Streets around the blockage to at least minimize the overflow volume. The Department utilized an 8-in Godwin pump but there was so much debris in the sewer that the suction strainer kept getting clogged, as can be seen in **Photos 9 and 10**. Staff removed the strainer from the suction line to see if that would help, which resulted in the debris clogging the impeller, which rendered the pump inoperable. The Department contacted a local company that the City rented pumps from in the past to see if they might be able to supply a non-clog that would be capable in handling the debris and volume of water. They would be able to supply a 12-in hydraulic pump but we would have the same problem with the pumps clogging, just on a bigger scale. Department staff kept using the combination truck to remove the debris from the manhole on Market and Walnut Sts.

Photo 9 – Debris collected around the strainer on the 8in Godwin Pump suction line

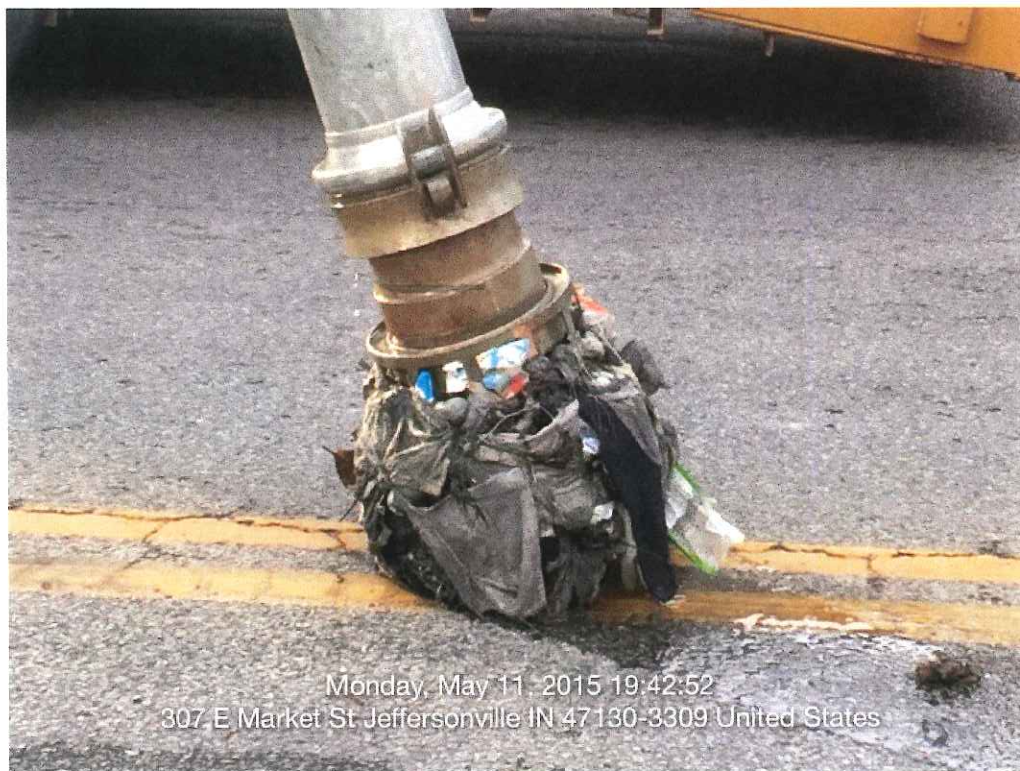
Photo 10 – Debris on pump suction line strainer

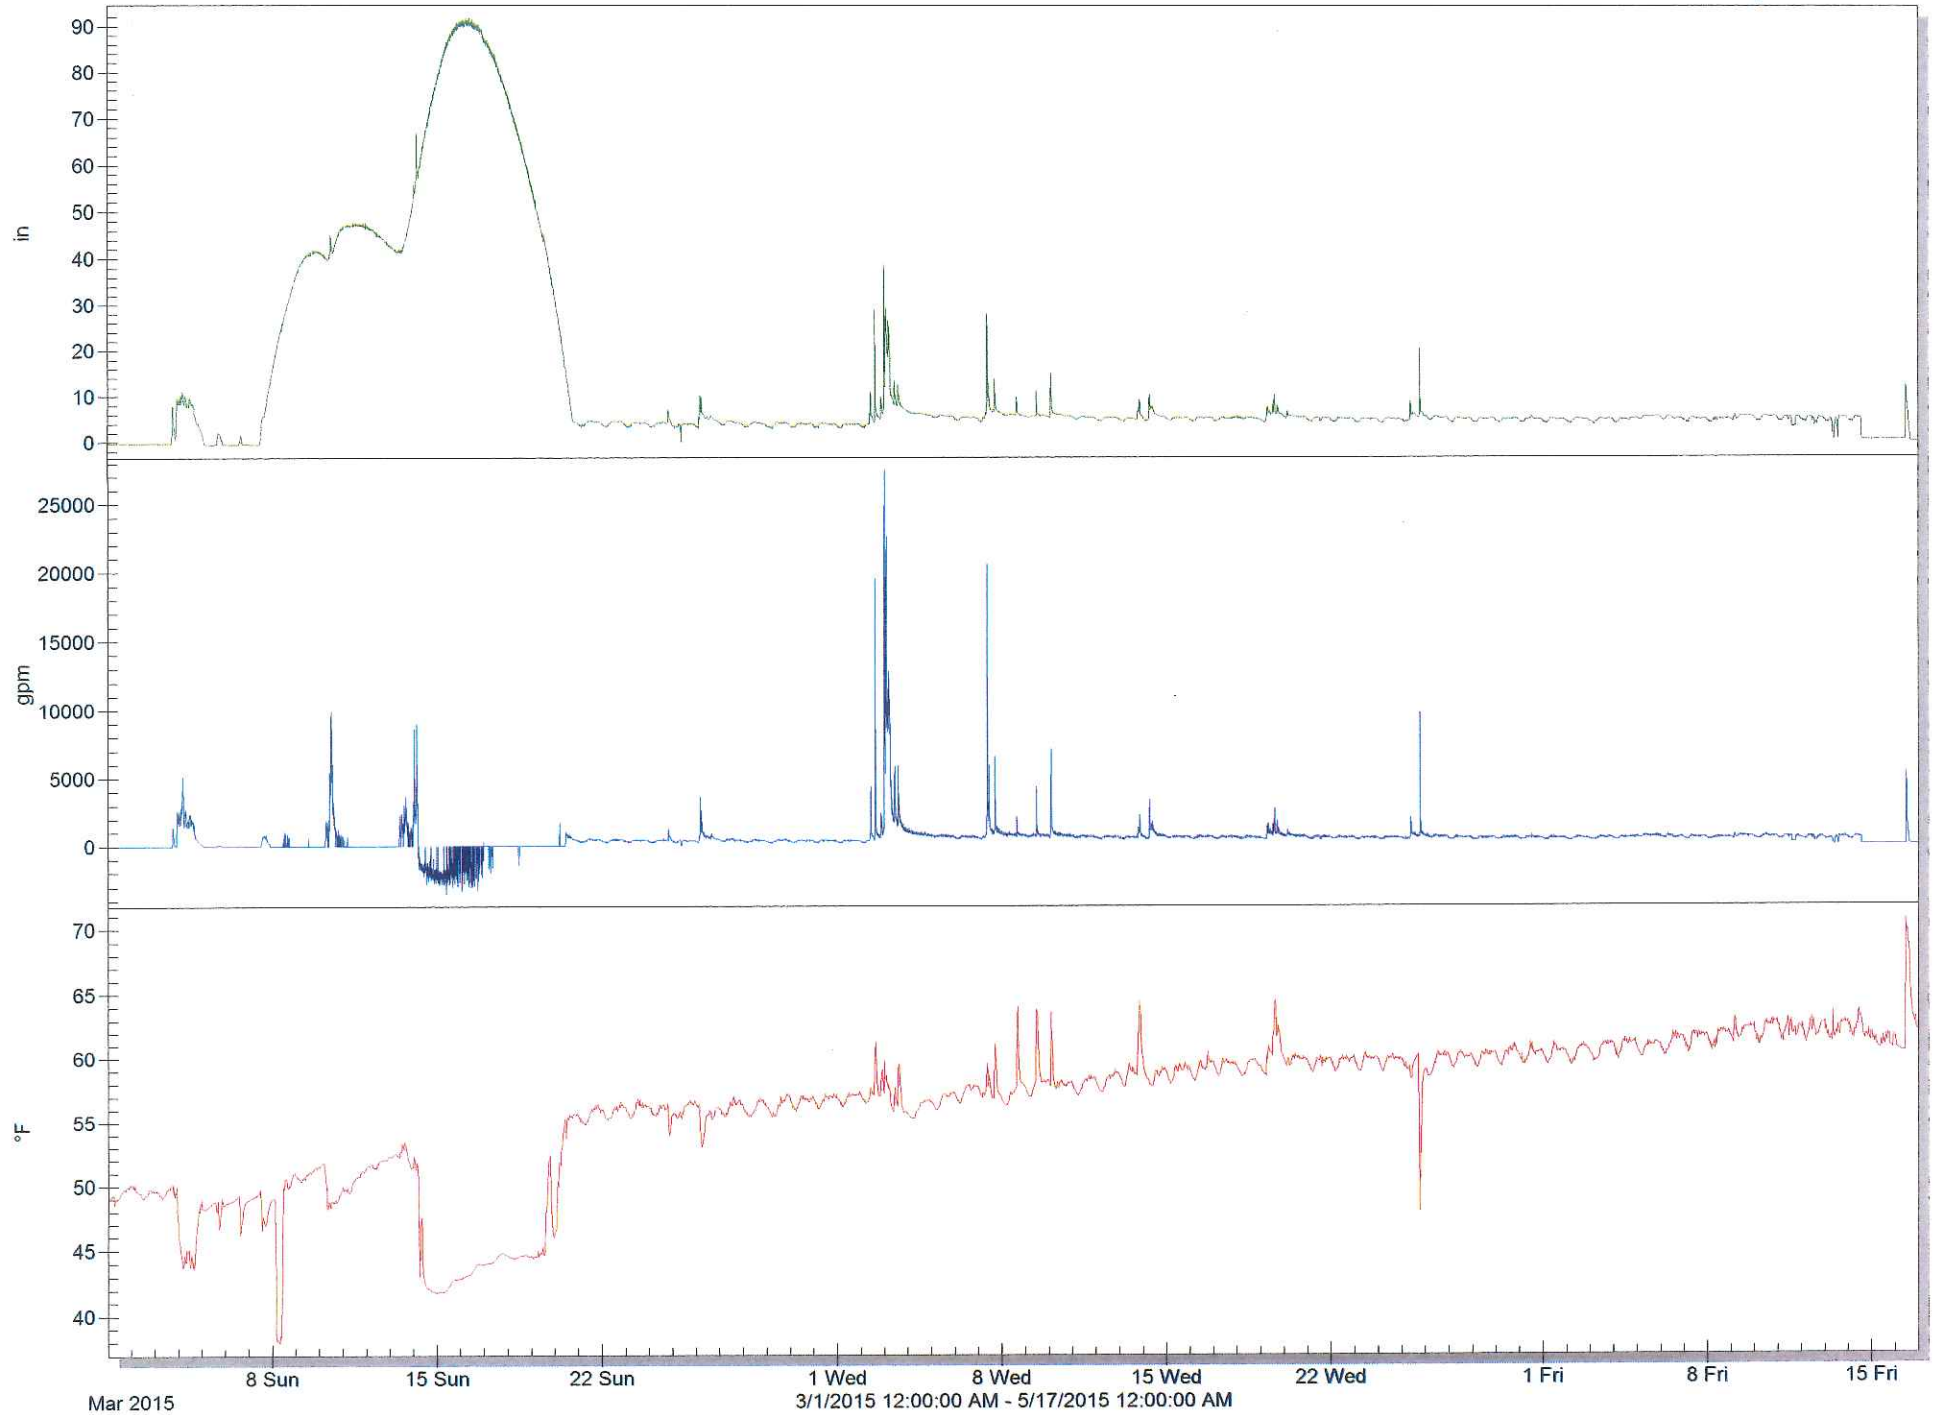
The Department believes that the flood stage in the Ohio River caused problems with the hydraulic conditions in the Market Street Interceptor. **Attachment 1** contains all of the CSO event data for the CSOs that discharge into the Ohio River and the Ohio River levels for the period of March 1 through May 16, 2015.

021 Mechanic CSO 36 inch.36 inch.Level

021 Mechanic CSO 36 inch.36 inch.Flow Rate

021 Mechanic CSO 36 inch.36 inch.Temperature
